REPUBLIC OF THE MARSHALL ISLANDS Maritime Administrator

BARU MARINE SAFETY INVESTIGATION REPORT Fatal Fall From Height

Offshore Anchorage, North Sea | 20 July 2021

IMO Number: 9813096

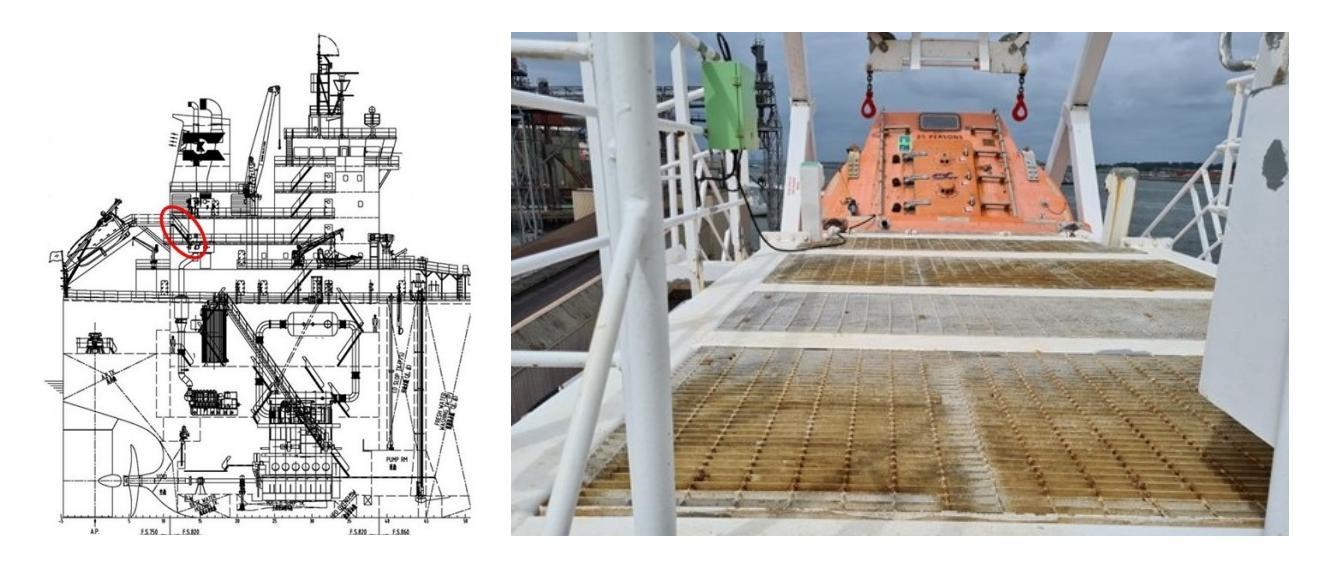
14. The free-fall lifeboat davit was located aft of the Accommodation on BARU's starboard side. Access to the platform of the davit was by an inclined ladder between the B Deck and the platform *(see Figure 2)*. The platform was approximately 8.5 m above the Poop Deck and consisted of four sections of removable grating.

Figure 2: Free-fall lifeboat davit. The inclined ladder between the B Deck to the platform on the davit is circled in red on the portion of the General Arrangement drawing that is shown on the left. The platform with the four removable sections of grating is shown in the picture on the right.

- 41. When examined after the Deck Cadet fell, the inclined ladder, including its handrails, the free-fall lifeboat davit and platform, and the guard rails around it were all found in good condition and free of structural defects.

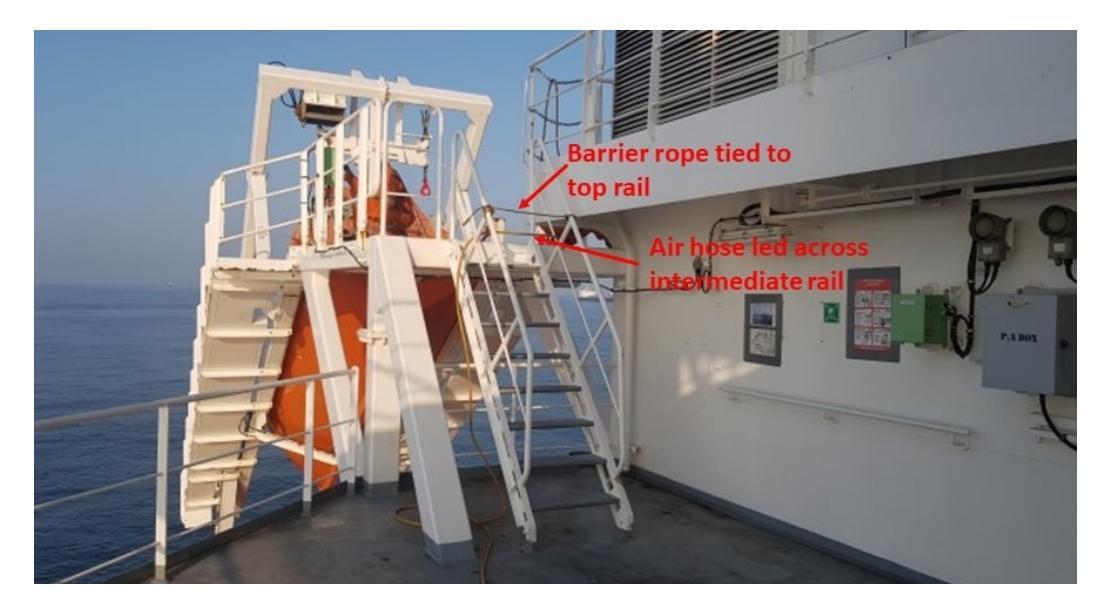
- 21. After they had chipped around the section of grating closest to the inclined ladder, the ASD and OS disconnected the lifelines that were connected to the guard rail.⁷ The ASD then rigged a physical safety barrier across the ladder by tying a rope to the top rails. An air hose that was being used by the ASD and OS was led over the intermediate rail directly below the rope used to create a barrier. Both the rope and air hose were positioned so that they were about two to three steps below the top of the ladder (*see Figure 3*). A warning sign was not posted.

Figure 3: Access ladder to the free-fall lifeboat davit platform showing the rope used to establish a physical safety barrier and the air hose. Note: This picture was taken after the Deck Cadet had fallen and the barrier rope had been retied.

- 27. The ASD and OS reported observing that the rope safety barrier was untied at one end as they went down the inclined ladder. They also reported seeing the Deck Cadet's safety helmet lying on its side on B Deck, approximately 2 m from the base of the ladder.

- (i) the supervision of cadets who might be on board the ship to which the officer is being assigned; and
- (ii) compliance with the Company's safe work procedures;
- (c) revise the safe work procedures in their SMS to require:
 - (i) that when planning a task for which a Safety Standby Person is required, that the assessment of the site where the work will be performed includes a determination if additional Safety Standby Persons are needed to effectively monitor the entire work area for hazards and to ensure other crewmembers or other persons do not enter the area while the planned work is being conducted; and
 - (ii) that all designated Safety Standby Persons acknowledge their assigned duties by signing the relevant work permit.

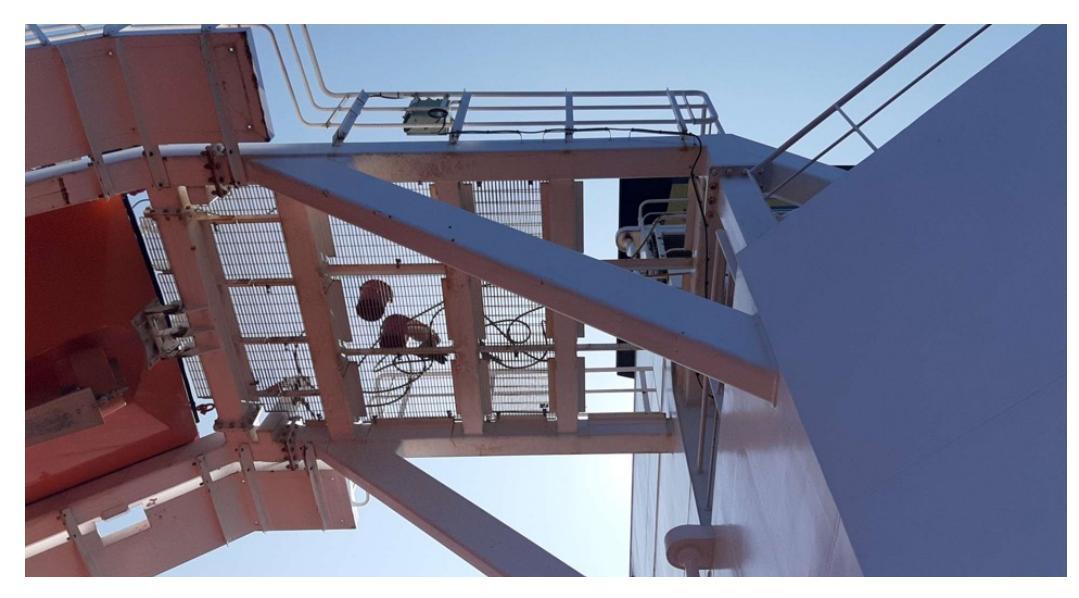
22. After rigging the safety barrier, the ASD and OS removed the section of grating that was closest to the inclined ladder *(see Figure 4)*. The ASD and OS then both reconnected the lifelines that had previously been disconnected from the guard rail. After checking to make sure that the lifelines were securely connected, they started chipping the portion of the platform structure to which the grating was secured.⁸ This portion of the structure could not be chipped with the grating in place.

Figure 4: View of free-fall lifeboat davit platform from below with the section of grating closest to the inclined ladder removed.

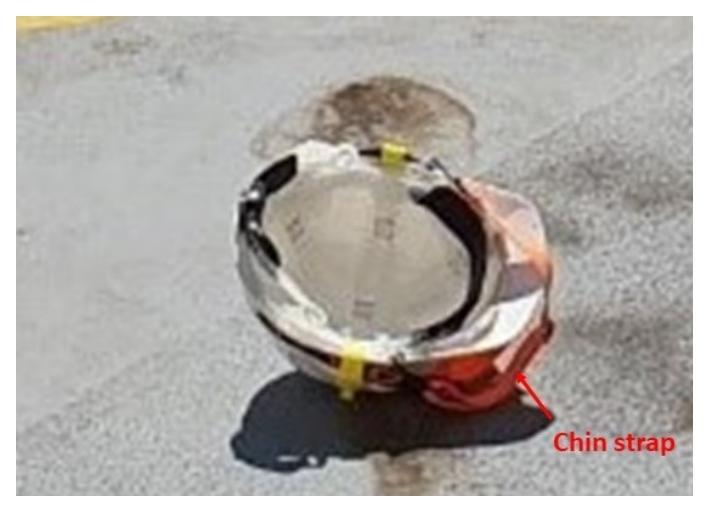
- 28. Based on the information available to the Administrator, it is not known if the Deck Cadet was using the chin strap on his safety helmet to secure it on his head before he fell. The chin strap was loose with both ends connected to the safety helmet when it was examined after he fell *(see Figure 5)*.

Figure 5: Deck Cadet's safety helmet. Note the position of the chin strap.
