# **REPUBLIC OF THE MARSHALL ISLANDS** Maritime Administrator

HAPPY HIRO MARINE SAFETY INVESTIGATION REPORT

Collision with Fishing Vessel

Philippine Sea | 28 May 2022

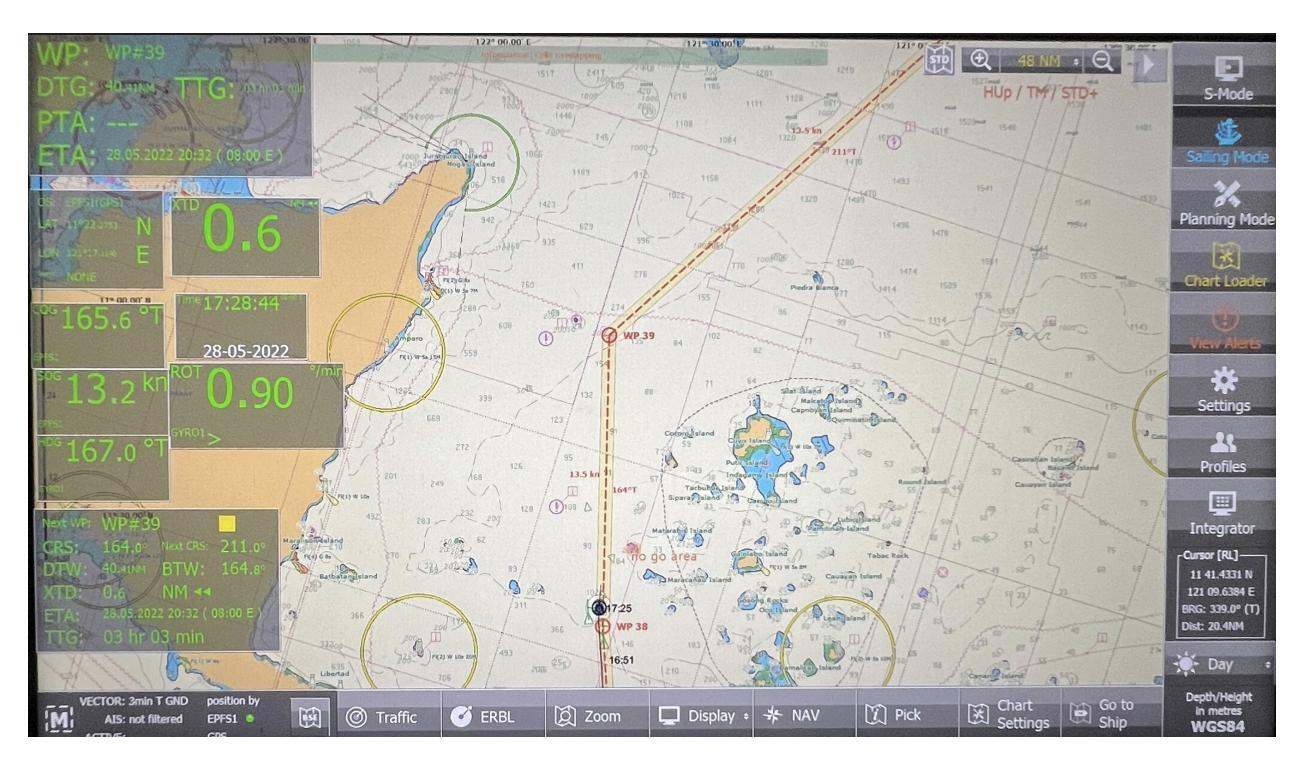
Figure 3: ECDIS screenshot showing position of HAPPY HIRO at 1728 on the day of the collision.

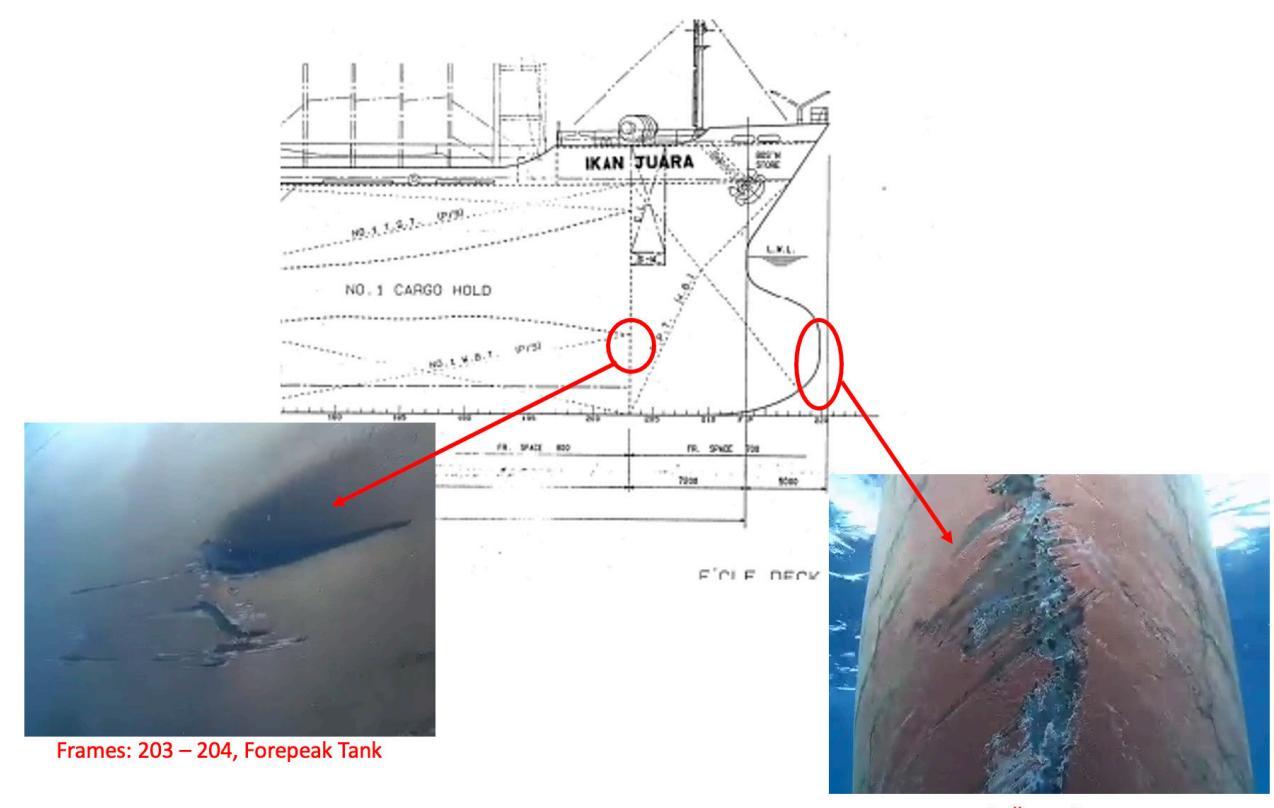
**Bulbous Bow**

23. HAPPY HIRO sustained minor damage in way of deformation of shell plating located at the fore-end of the bulbous bow and deformation and scratches on the starboard side in way of frames 203-204 (forepeak tank) beneath the waterline. In addition, rope was found entangled around the propeller shaft.

Figure 6: Damage sustained to HAPPY HIRO's bulbous bow and starboard side in vicinity of frames 203-204 (forepeak tank).

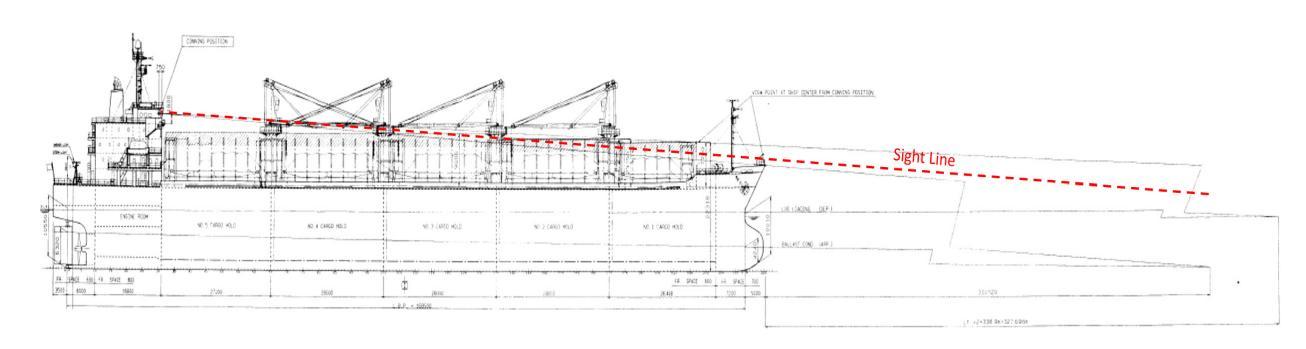
38. Based on HAPPY HIRO's actual ballast condition on 28 May, the sight line from the CP was in between the full load condition of 327.6 m and the ballast condition of 310.5 m *(see preceding table and figure 7)*.

Figure 7: Sight line from the CP based on the actual loading condition on 28 May.

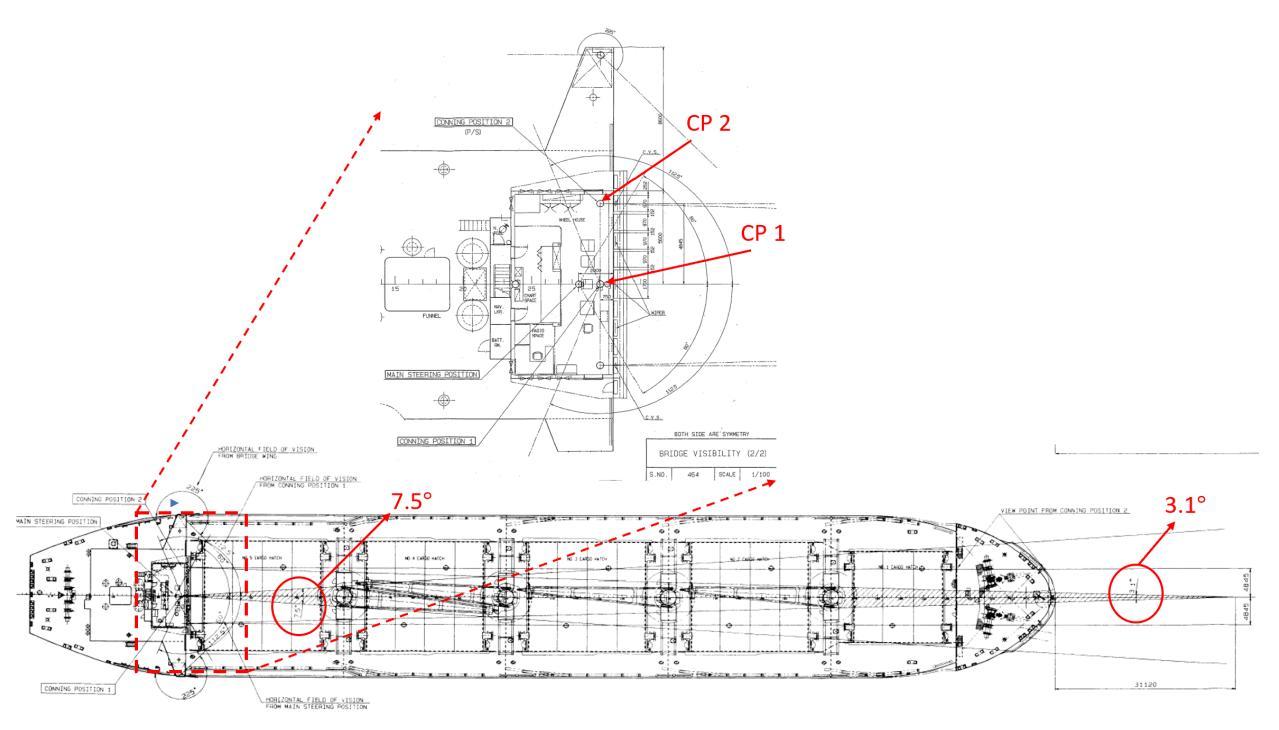
- 39. SOLAS regulation V/22.1.2 stipulates that no blind sector, caused by cargo, cargo gear, or other obstructions outside of the wheelhouse forward of the beam which obstructs the view of the sea surface as seen from the CP, shall exceed 10°. The total arc of blind sectors shall not exceed 20°. The clear sectors between blind sectors shall be at least 5°. However, in the view described in V/22.1.1,<sup>13</sup> each individual blind sector shall not exceed 5°.
- 40. Figure 7 was generated from the Class approved Navigation Bridge Visibility<sup>14</sup> plan and demonstrates that from the centerline CP 1 the blind sector is 7.5°, and from the forward corner of the bridge (CP 2) the blind sector is 3.1°. The navigational bridge visibility from CPs 1 and 2, respectively, conforms to the statutory requirements detailed within SOLAS regulation V/22.1.2.

Figure 8: Navigational Bridge Visibility blind sectors from CP 1 (7.5°) and CP 2 (3.1°) circled in red.

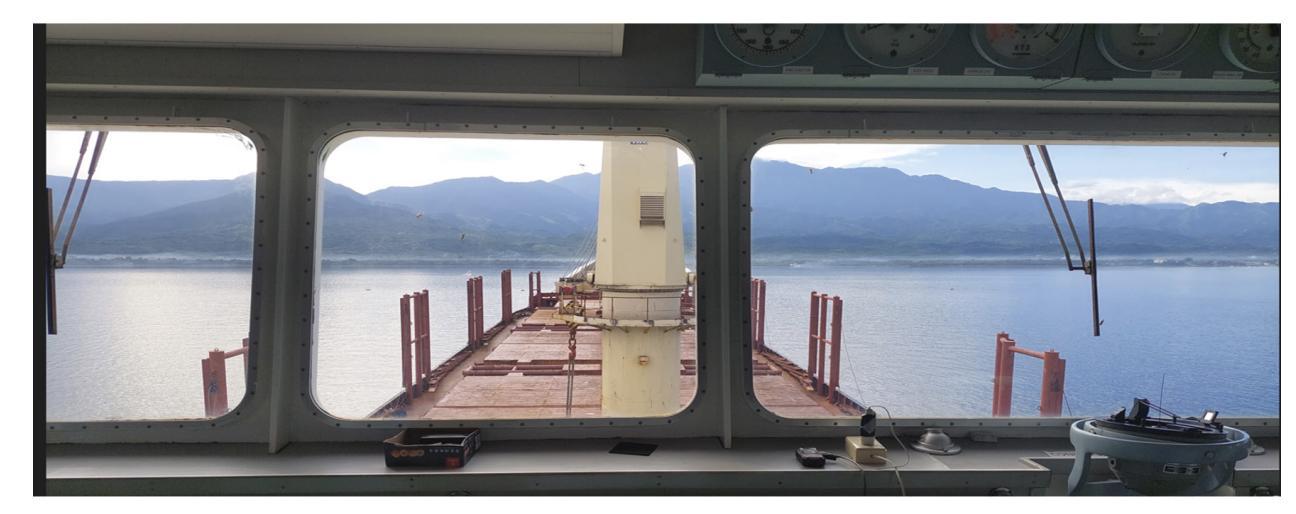
Figure 10: View from behind the S-Band radar, approximately 1 m to the left of CP 1.

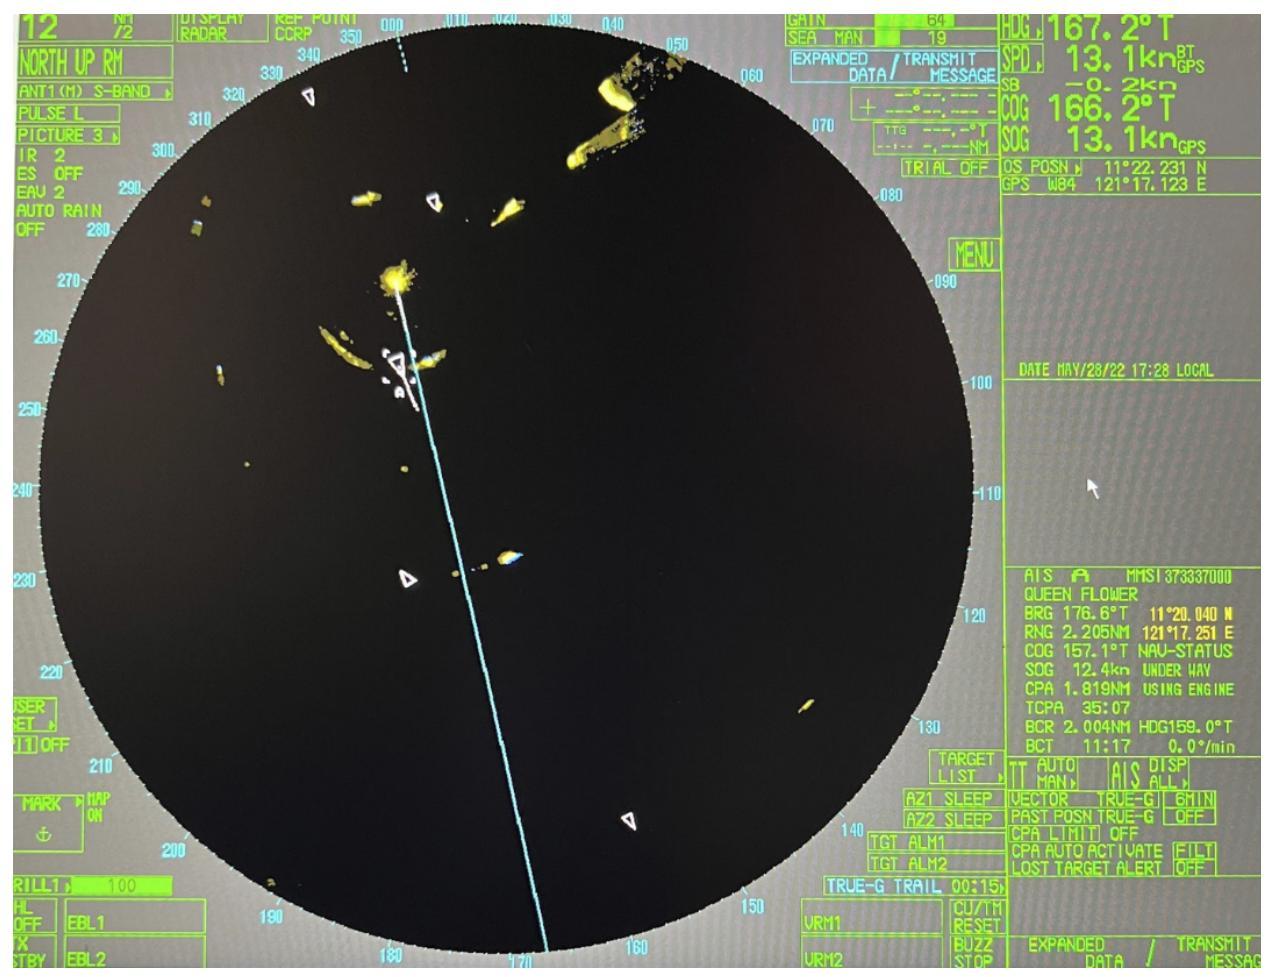
- 47. The radar display has a significant amount of clutter surrounding the known contacts. The radar has the capability to automatically adjust clutter to account for environmental conditions in order to define contacts more clearly. Alternatively, the operator (OOW) can adjust the rain, gain, and sea functions of the radar manually (known as tuning) to enhance target identification. The radar settings selected indicate that the radar auto adjust function was deselected thereby requiring the operator to manually adjust the rain, sea, and gain for optimum performance.

Figure 11: S-Band Radar at 1728 on 28 May 2022.

The radar range scale in use (12 NM) was not effective in identifying small conspicuous contacts. In the knowledge that the OOW would likely encounter small, conspicuous contacts during the transit, it was assessed that the S-Band radar was not adequately set-up for the prevailing conditions.

At no stage during the watch did the 2/O alter the range scale of the S-Band radar in use at the time. A large quantity of scatter is displayed between the 0-3 NM range scale, which masked any contacts within this field and made it difficult to identify actual contacts over the scatter of clutter depicted *(see figure 10)*. COLREGs and the IMO Recommendation on Basic Principles and Operational Guidance Relating to Navigational Watchkeeping (Resolution A.285/VII), provides mandatory and recommendatory practices on the use of radar such that "whenever radar is in use, the OOW should select an appropriate range scale, observe the display carefully and plot effectively. The OOW should ensure that range scales employed are changed at sufficiently frequent intervals so that echoes are detected as early as possible."
