### TRF KASHIMA MARINE SAFETY INVESTIGATION REPORT

Fatal Enclosed Space Entry

South China Sea | 14 July 2024

IMO Number: 9733349

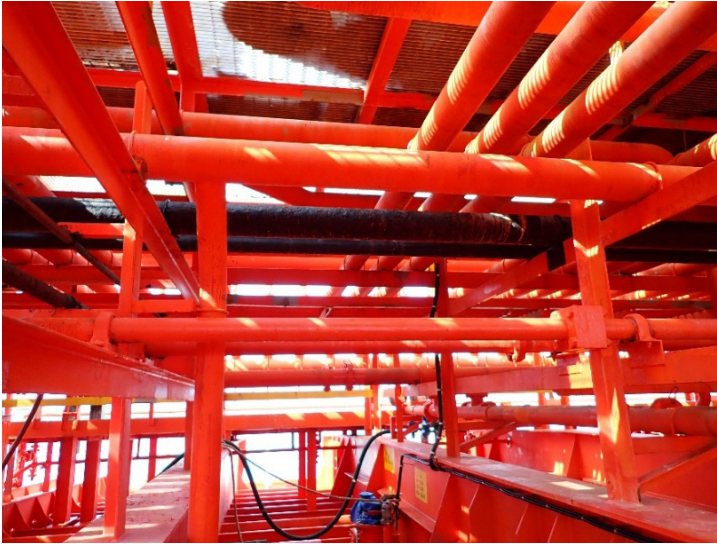
Except for the Pumpman and OS2, none of the other crewmembers who were on deck, nor the OOW on the Bridge, had a direct line of sight to the cargo tank dome for No. 6 S CT due to the external frames and the grating and cargo pipelines that were located above the main deck between the port and starboard side manifolds (see Figure 3).

Figure 3: Grating and cargo pipelines above the cargo tank dome for No. 6 S CT.

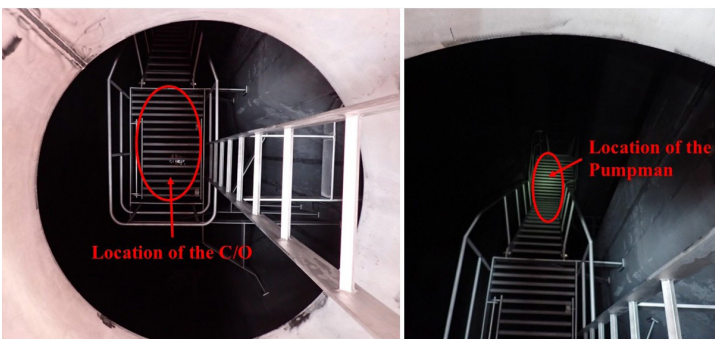
By 1649, the Master, the 2/O, and other crewmembers had arrived at the cargo tank dome for No. 6 S CT with SCBAs, extra air bottles, gas detectors, EEBDs, and rescue harnesses with lines. Through the open access hatch they observed that the C/O was lying on the top platform, and that the Pumpman was lying on the second platform (see Figure 4). They could not see the OS2.

Figure 4: No. 6 S CT access ladder. The vertical ladder from the cargo tank dome to the upper platform is shown in the photograph on the left. The inclined ladder between the upper platform and the second platform is shown in the photograph on the right. The locations where the C/O and Pumpman were found are circled in red. The OS2 was found lying under the Pumpman.

The 2/O and ASD1 entered No. 6 S CT. They observed that the C/O was unconscious but had a pulse and was gasping for breath. An EEBD was placed over his head. They were not able to put a rescue harness on the C/O because of how he was lying on the platform, so they tied a line around his torso. Crewmembers on deck then hoisted the C/O out of the cargo tank at 1653. The C/O was laid on the deck and administered medical oxygen. He regained consciousness a short time later.

The 2/O and ASD1 exited No. 6 S CT and at 1654 a second rescue team consisting of the ASD3 and an Oiler, both of whom were wearing SCBAs, entered No. 6 S CT. They observed that the Pumpman was lying unconscious on top of the OS2 on the second platform (see Figure 4). The second rescue team tried to put a rescue harness on the Pumpman but, due to limited space, they were unsuccessful. After the rescue team tied a line around the Pumpman's torso, he was hoisted out of the cargo tank by crewmembers and placed on the main deck at 1701.

A third rescue team, which was made up of the JWKO and OS1, wearing SCBAs then entered No. 6 S CT. They placed an EEBD over the OS2's head before attempting to put a rescue harness on him. They were unable to put a rescue harness on him and tied a line around his torso. By 1705, the OS2 had been hoisted out of the cargo tank and was laid on the main deck.

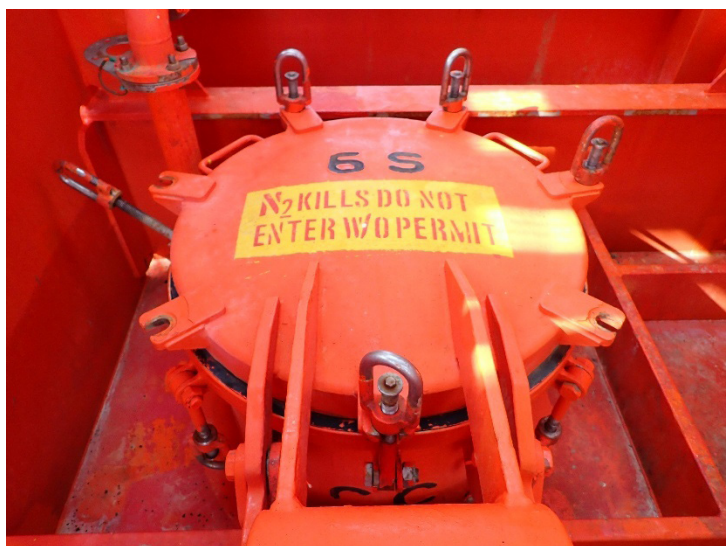
1. all entrances to enclosed spaces be marked "DO NOT ENTER WITHOUT PERMIT" (see Figure 7);
2. no person was to enter an enclosed space without permission from the ship's Master;
3. ventilation be started well before entry and continued while the space was occupied and that if only natural ventilation was possible that the space be allowed to "breathe" for at least 24 hours; and
4. the atmosphere inside the space be checked before entry at several levels before an entry permit was issued, immediately before entry, and re-checked at pre-determined intervals not to exceed 30 minutes.

Figure 7: No. 6 S CT access hatch. Every cargo tank access hatch on board TRF KASHIMA was marked with "N2 KILLS" in addition to the warning required by the Company's enclosed space entry procedures.

11. Revised the Company's cargo tank tagging system to require that red tags be placed on all cargo tank hatches during cargo tank cleaning operations, whether or not entry into the cargo tanks is planned, and that the red tag be replaced with a green tag after the atmosphere inside the cargo tank is determined safe for entry and an enclosed space entry permit has been issued.

12. Painted nitrogen warnings on cargo tank hatches were replaced with yellow triangular nitrogen hazard tags, which were placed on cargo tank hatches only when the applicable cargo tank contained nitrogen.
