Office of the Maritime Administrator

F/V KOO'S 101 CASUALTY INVESTIGATION REPORT

Main Boom Structural Failure with Loss of Life

18 June 2011

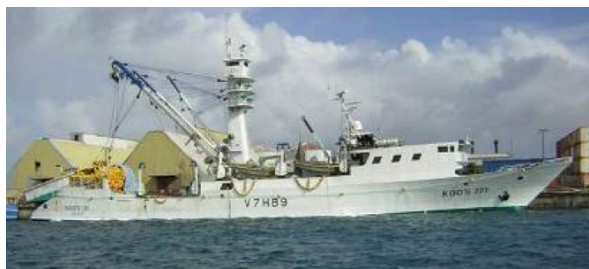
Figure 1: KOO'S 101

2. KOO'S 101 is an 1152 gross ton (GT) purse seiner built in 2005 by Ching Fu Shipbuilding Co., Ltd, based in Kaohsiung, Taiwan, fitted with a single main boom and two auxiliary booms and is a Japanese-style purse seiner design. *See Figure 1.* Since delivery, KOO'S 101 has been owned and operated by Koo's Fishing Company Limited and registered in the Republic of the Marshall Islands.

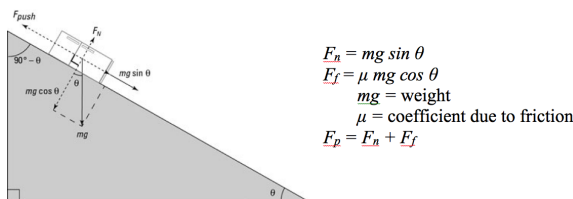
Figure 10: Forces of an object on a ramp.

The force necessary to pull the skiff boat up the stern ramp is a function of the skiff boat's weight, the angle of the stern ramp from the horizontal and the coefficient due to friction. *See Figure 10.*

The coefficient of friction will also vary based on whether the skiff boat is at rest, i.e., static friction, or moving, i.e., kinetic friction. The coefficient of friction is also sensitive to whether there is an oxide film on one or both of the surfaces. The effect of oxide is to reduce the coefficient of friction.⁸

Based on the information available, the actual force needed to move the skiff boat up the ramp of KOO'S 101 when the main boom upper topping lift failed cannot be determined. However, it is likely that it was lower than the calculated force since the bottom of the skiff boat and stern ramp had some surface rust, i.e., iron oxide.
