REPUBLIC OF THE MARSHALL ISLANDS Maritime Administrator

BARU MARINE SAFETY INVESTIGATION REPORT Fatal Fall From Height

Offshore Anchorage, North Sea | 20 July 2021

IMO Number: 9813096

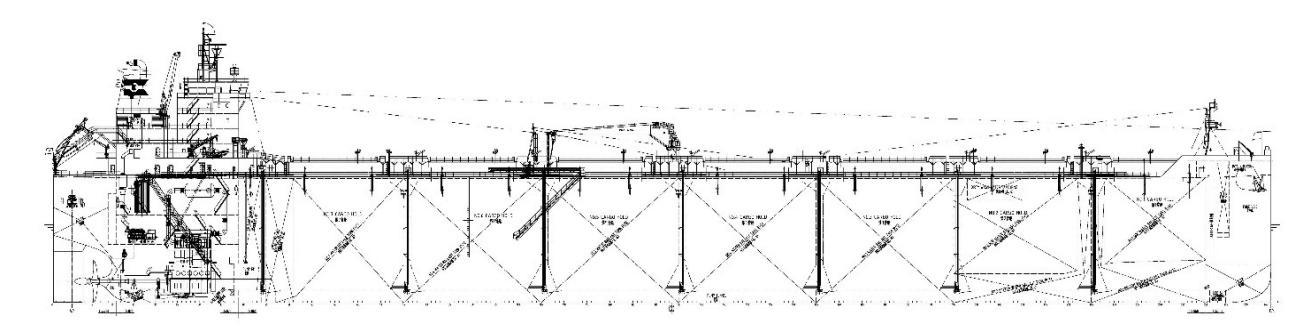
Figure 1: BARU General Arrangement.

- 1. Ship particulars: see chart on page 9
- On 20 July 2021, the seven cargo hold combination carrier BARU (see Figure 1) was anchored off Rotterdam, Netherlands in offshore anchorage No. 4W while awaiting berthing instructions. The ship's drafts were 13 m forward and aft.
