REPUBLIC OF THE MARSHALL ISLANDS

EAUBONNE CASUALTY INVESTIGATION REPORT

Ordinary Seafarer Fatality

South Atlantic Ocean | 25 June 2021

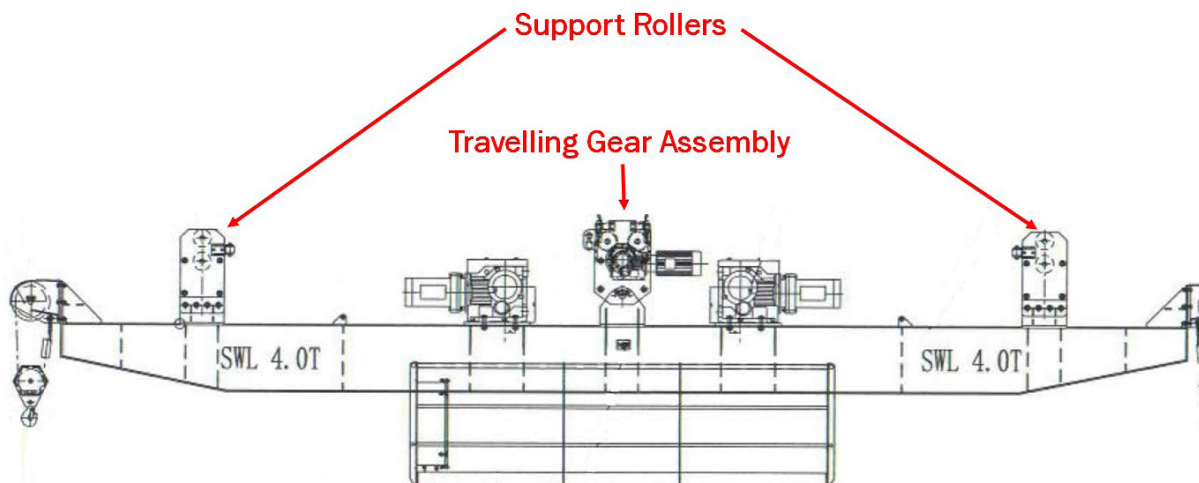
Figure 3: Diagram of the ECM40 provision crane installed aboard EAUBONNE, showing the travelling gear assembly and support rollers.

7. The provision crane moved along the fixed monorail on two sets of support rollers and one travelling gear assembly (see Figures 2 and 3). The travelling gear assembly was powered by an electric motor, while the support rollers were not powered. The travelling gear was used to move the provision crane port and starboard along the fixed monorail by means of a pinion gear, which engaged a rack attached to the bottom side of the fixed monorail.

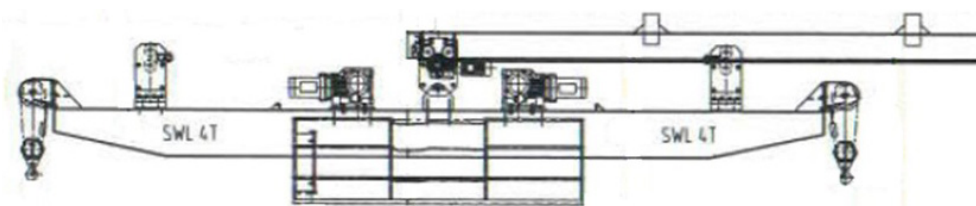
Figure 4: Diagram of the provision crane while extended beyond the side of the ship.

8. When in use, the provision crane extended outward, beyond the side of the ship, while being supported by the travelling gear assembly and one set of support rollers (see Figure 4).

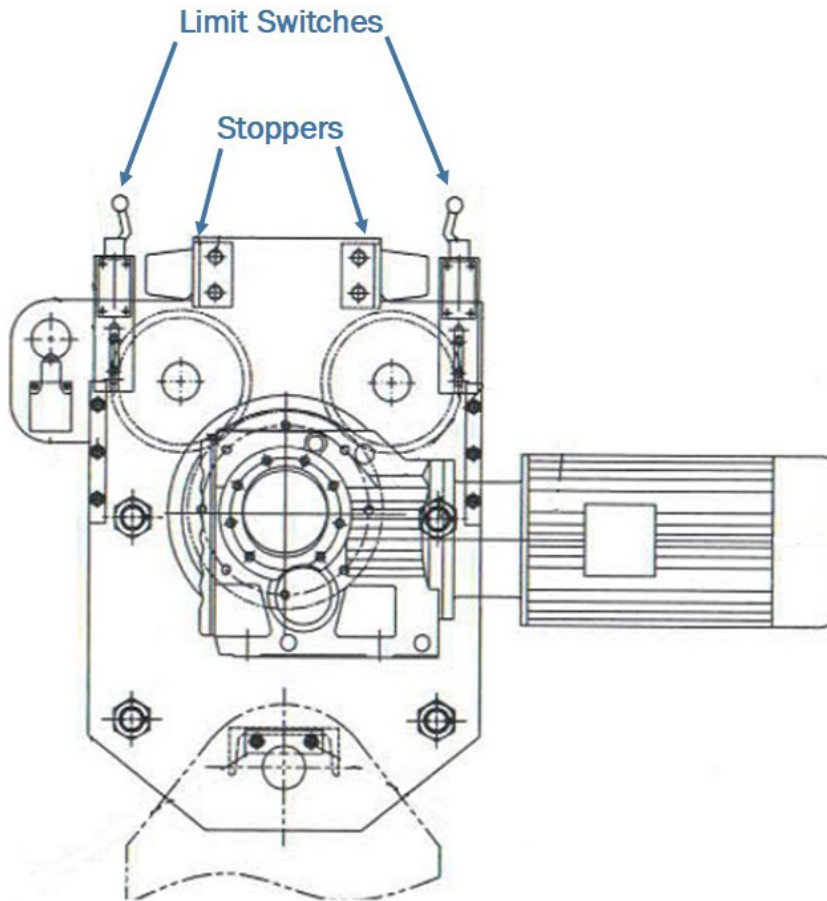
Figure 5: Profile diagram of the travelling gear, from the aft side.

- Two mechanical spring arm limit switches were installed on the aft side of the travelling gear assembly. One switch was activated when the provision crane was fully extended to port, while the other activated when fully extended to starboard. The travelling gear assembly was also fitted with four stoppers, one at the port and starboard sides of each end (see Figure 5).

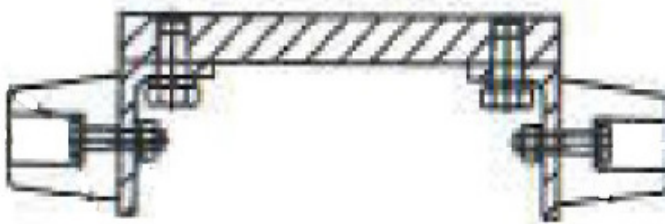
Figure 6: Diagram of the design of the stoppers installed on travelling gear, as viewed from above.

- The stoppers were made of pieces of steel angle, bolted to the frame of the travelling gear assembly, and fitted with rubber bumpers (see Figure 6). The stoppers were not provided with support brackets or other strengthening.

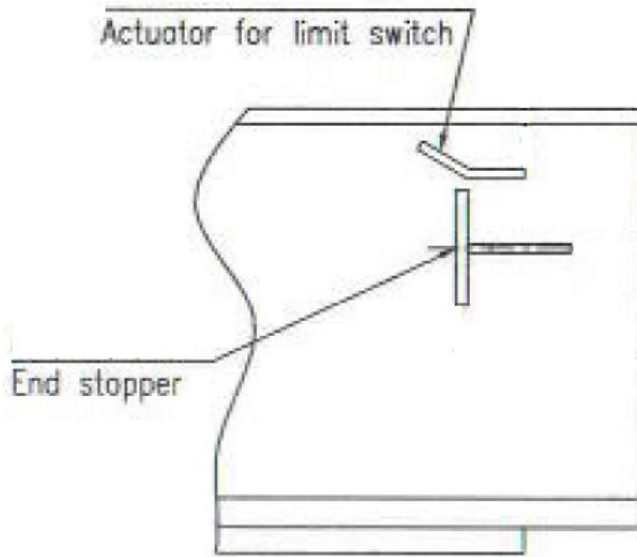
Figure 7: Diagram of the starboard end of the aft side of the fixed monorail showing the position of the bracket for engaging the limit switch and the stopper.

11. The technical drawings for the provision crane specify that the forward and aft sides of each end of the fixed monorail be fitted with stoppers to engage the stoppers on the travelling gear (see Figure 7). The stoppers are 160 mm from the ends of the fixed monorail. The drawings also specify that each end of the aft side of the fixed monorail be fitted with brackets to engage the limit switch when the crane was fully extended.

12. The end stoppers on the fixed monorail consisted of steel plates with steel reinforcement brackets on the outboard side, located 160 mm inboard from each end.
13. As designed, the limit switch on the travelling gear assembly would be activated at about the same time as the stoppers contacted.
14. The provision crane was operated by a handheld controller, which was attached to a 7 m cable. This cable was connected at the starboard side of the service platform that was installed on the provision crane (see Figure 8).
