# **REPUBLIC OF THE MARSHALL ISLANDS** Maritime Administrator

HAPPY HIRO MARINE SAFETY INVESTIGATION REPORT

Collision with Fishing Vessel

Philippine Sea | 28 May 2022

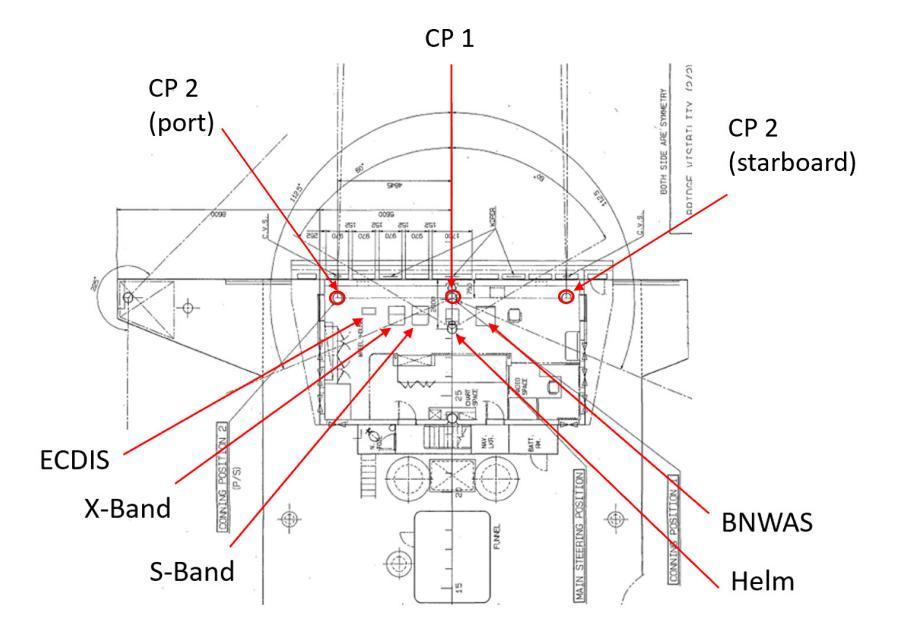
- 41. Based on the departure draft, the 2/O's visual horizon from the Bridge of HAPPY HIRO was approximately 10 NM.
- 42. The location of the ECDIS terminal and BNWAS was not in vicinity of CP 2. When standing behind the S-Band radar, the view directly ahead of the vessel is restricted by the presence of the forward gantry cranes *(see figure 9)*. The location of CP 2, port and starboard respectively, provided a clear unobstructed view directly ahead of the vessel.

Figure 9: Bridge equipment and CPs 1 and 2.
