REPUBLIC OF THE MARSHALL ISLANDS

KG ASIA CASUALTY INVESTIGATION REPORT

Enclosed Space Fatality

Boryeong, Republic of Korea | 6 January 2020

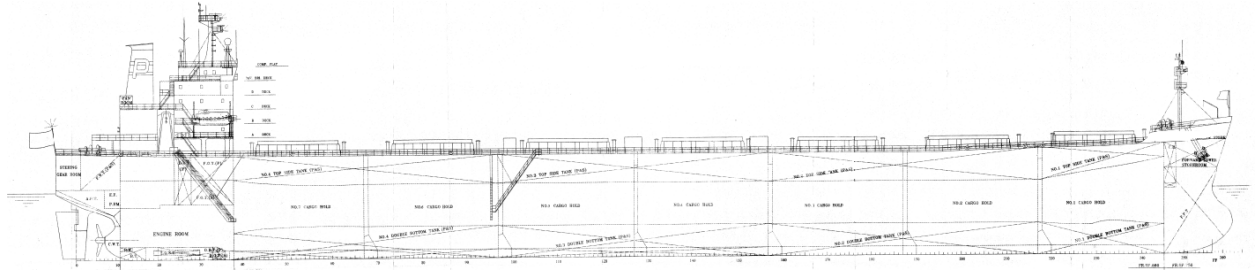
Figure 1: General arrangement of KG ASIA.

2. KG ASIA is a bulk carrier with seven cargo holds, which are fitted with port and starboard sliding hatch covers (see Figure 1).
