MANTA HULYA MARINE SAFETY INVESTIGATION REPORT

Collision with the Republic of Tunisia Registered Fishing Vessel RAZI

Mediterranean Sea | 12 February 2022

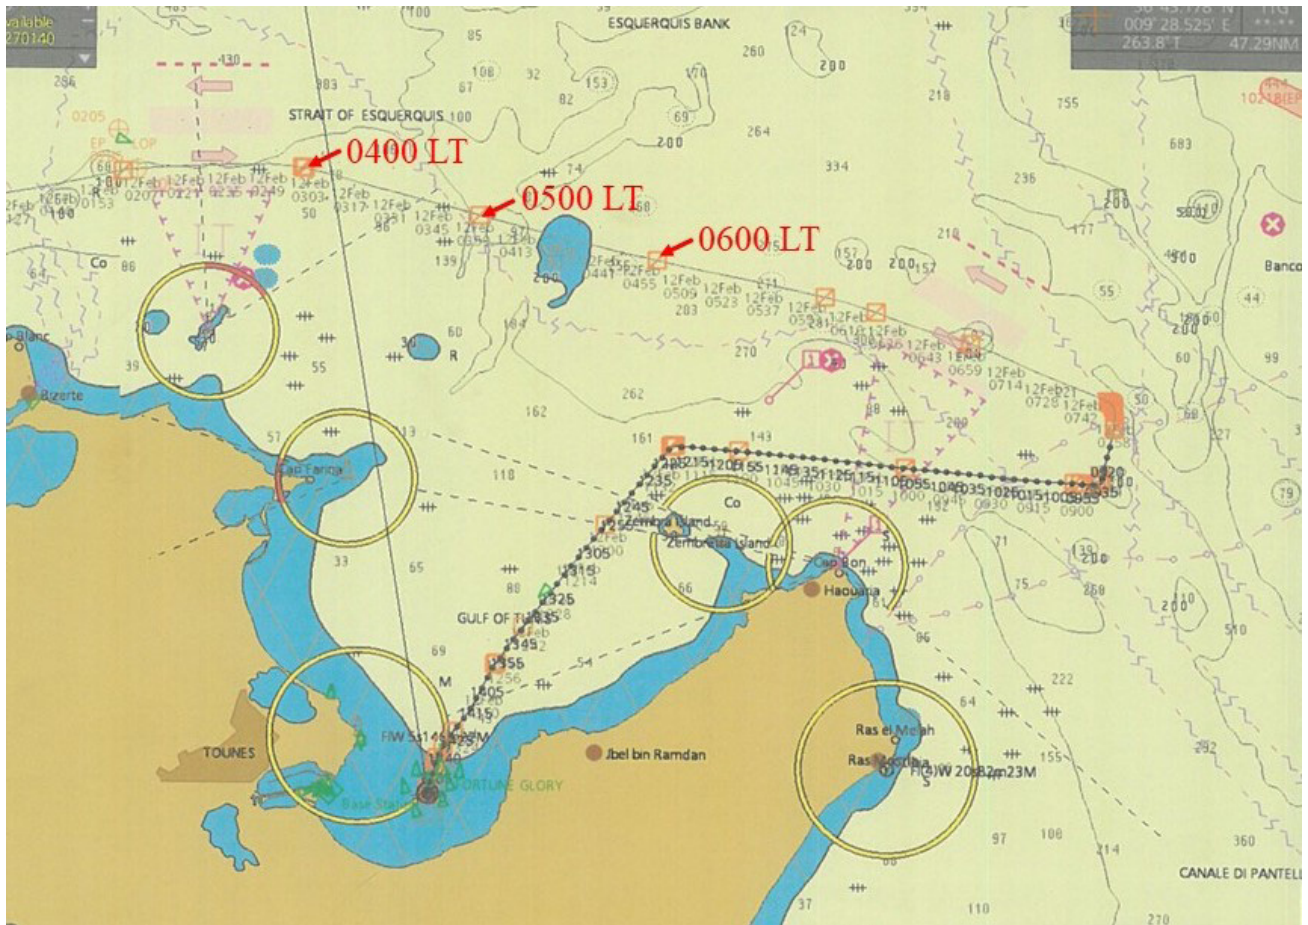
Figure 2: Image of MANTA HULYA's track on the morning of 12 February 2022. The ship's positions at 0400, 0500, and 0600 are shown in red. (Source: MANTA HULYA's ECDIS)

MANTA HULYA's OOW reported observing dense vessel traffic consisting of fishing vessels directly along the ship's planned route, which was the most direct route between the two TSSs off the coast of Tunisia (see Figures 2 and 3). All of these vessels appeared to have bright white deck lights on that made it difficult to see their navigation lights. He stated that between approximately 0420 and 0530 it was necessary to maneuver several times to avoid colliding with the fishing vessels that were encountered.⁶ The maneuvers were made by adjusting the autopilot. The CPA watch alarm on the ARPA was set for 1 NM.

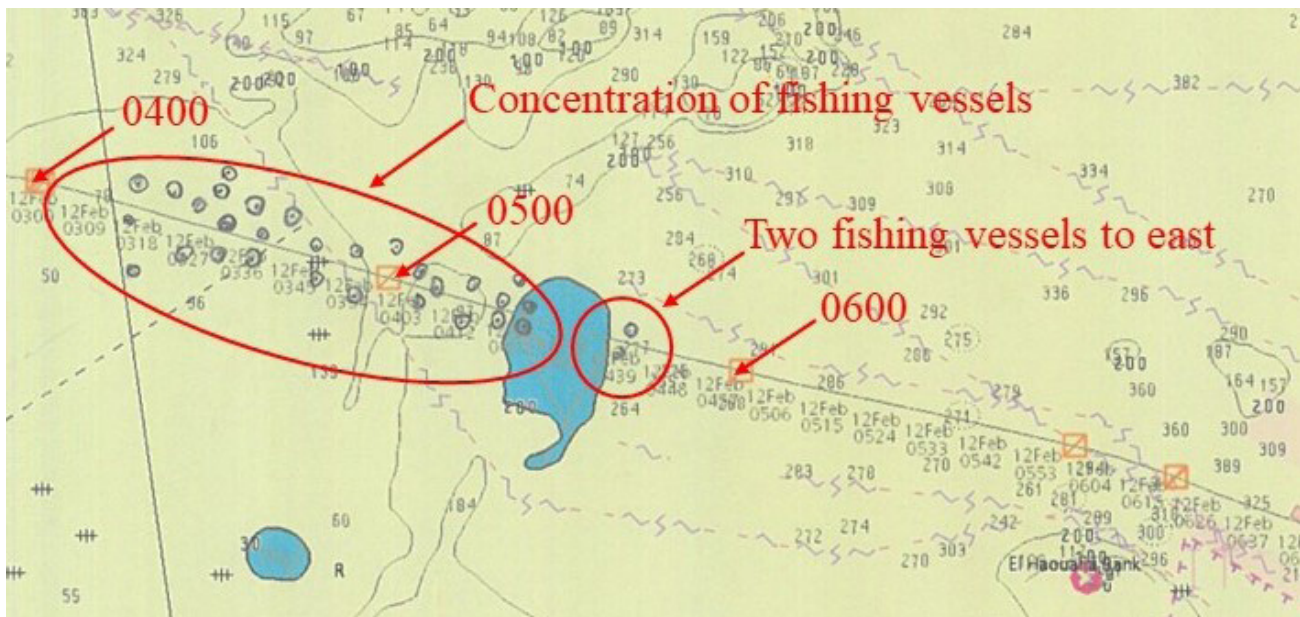
Figure 3: Plot of MANTA HULYA's track showing the concentration of fishing vessels along the ship's track and the two fishing vessels that were observed by the OOW at 0530. Note: The dots were drawn by the C/O who had been on duty as the OOW.

At approximately 0530, MANTA HULYA's OOW and Lookout observed two fishing vessels to the east of the concentration of fishing vessels the ship had just passed (see Figure 3). Neither of these two fishing vessels appeared to be transmitting AIS information. One of these fishing vessels was RAZI, which was approximately 1.2 NM off MANTA HULYA's starboard bow. The OOW determined RAZI was underway on a northerly heading at a speed of approximately 2 kn. The second fishing vessel was approximately 2 NM off the ship's port bow and appeared to be not making way. The OOW said that based on their radar vectors it appeared that MANTA HULYA, which was on a course of 104° T at a speed of 12 kn, would pass between the two fishing vessels. He did not determine the range of the ship's CPA with either of these two fishing vessels, nor did he acquire either on the ARPA.⁷

MANTA HULYA's OOW and Lookout reported first seeing RAZI when it was approximately 1.2 NM off the starboard bow as the ship finished passing through the large concentration of other fishing vessels (see Figure 3). They also reported seeing another fishing vessel approximately 2 NM off the port bow at the same time.
