REPUBLIC OF THE MARSHALL ISLANDS

NAN BEI HU SAFETY INVESTIGATION REPORT

Occupational Fatality

Rio Tuba Anchorage, Republic of the Philippines | 16 March 2024

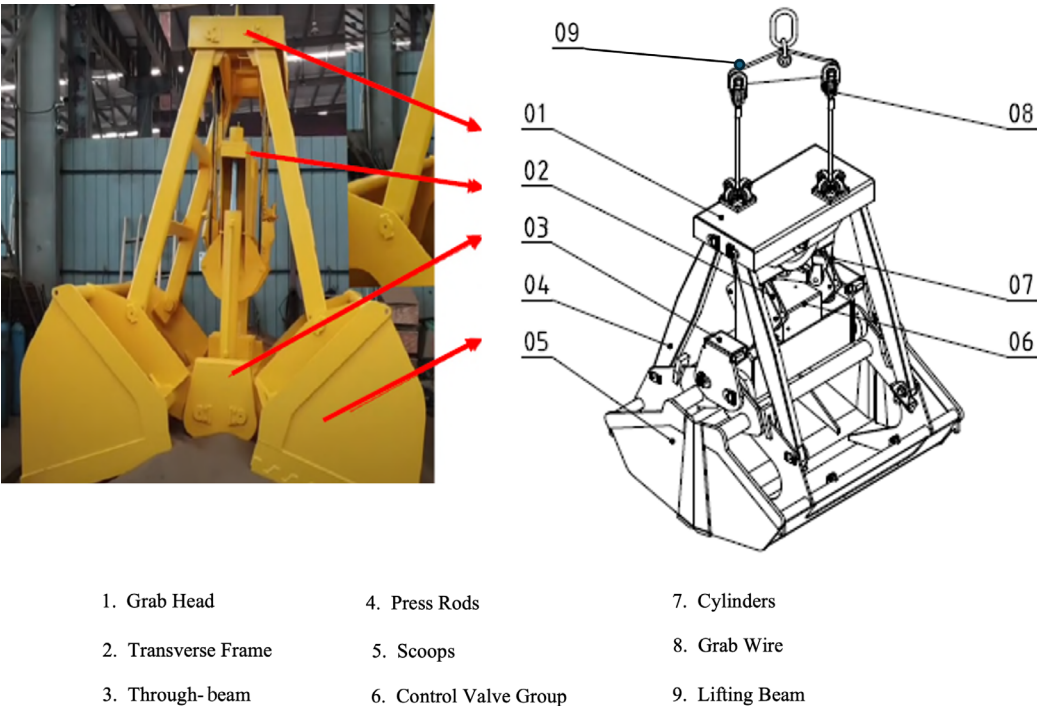
Figure 2: Grab layout.

NAN BEI HU was equipped with four RC024-5-12 radio remote-controlled grabs, manufactured by Shanghai Guanbo Machinery Equipment Co., Ltd (see Figure 2). The mass of each grab was 9,500 kg. The four grabs were placed on board when the ship was built in 2019.

Each of the four grabs had two grab wires. The working end of each of the grab wires had an eye splice and was secured by a shackle to the lifting beam. The dead (e.g., standing) end of the grab wires were secured to the transverse frame by means of a wedge socket.² The cylinder piston rods were connected to the transverse frame and the barrels were connected to the through-beam. The drain plug for the hydraulic oil was located on the bottom of the through-beam.

The grab scoops are opened while the grab is suspended using the remote control to activate a solenoid valve. Activating the solenoid valve allows hydraulic oil to flow into the lower portion of the cylinder barrels, displacing the oil that is in the upper portion of the cylinder barrels. This causes the piston rods, which are connected to the transverse frame, to extend, pushing the through-beam down. The downward movement of the through-beam causes the scoops to open. Pressure created by the hydraulic oil in the lower portion of the cylinder barrel controls the rate at which the through-beam moves downward and the scoops open.
