### OLYMPIA CASUALTY INVESTIGATION REPORT

Collision with Fishing Vessel

South China Sea | 9 March 2021

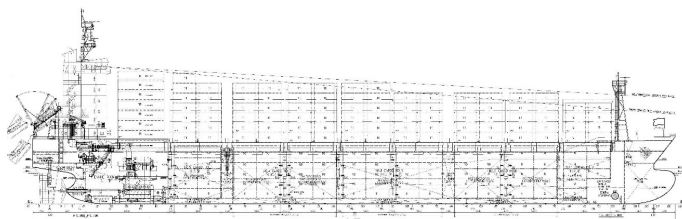
Figure 1: OLYMPIA general arrangement.

2. On the morning of 9 March 2021, the 1,717 TEU container ship OLYMPIA (*see Figure 1*) was underway on a voyage from Shanghai, China to Sihanoukville, Cambodia. The ship was laden with 497 containers of 20 and 40 ft. The ship's drafts were 7.1 m forward and 8.2 m aft.

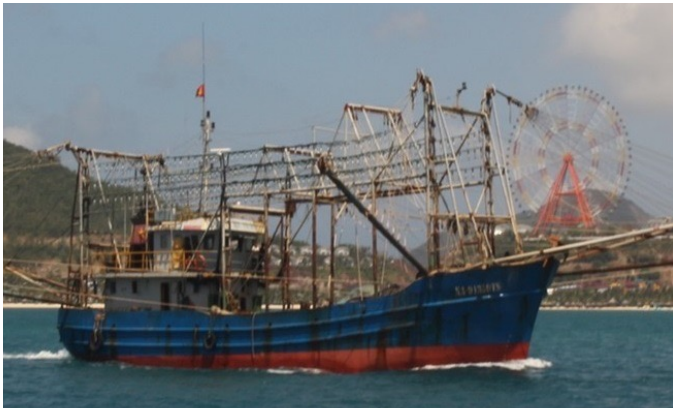
Figure 2: A fishing vessel of similar size and rig as TB-96666-TS. (Source: Vietnam Maritime Administration)

6. On the morning of 9 March 2021, the steel-hulled fishing vessel TB-96666-TS (*see Figure 2*) was hove to, using fender buoys as a sea anchor, and not engaged in fishing. The vessel's heading was northeasterly. A black diamond day shape was displayed forward.<sup>3</sup>

Considering that TB-96666-TS was a steel hulled vessel with the wheelhouse a deck above the main deck and that its rigging included several masts and booms (*see Figure 2*), it would be expected to provide a good radar return and might have been detected on radar before it could first have been seen by sight. Early detection using the radar would have provided the OOW ample time to monitor the vessel and determine if there was a risk of collision. Although radar might have permitted the OOW to detect TB-96666-TS sooner than he might have first seen it by sight, the use of radar is not a substitute for using sight to detect other vessels and assess the risk of collision.

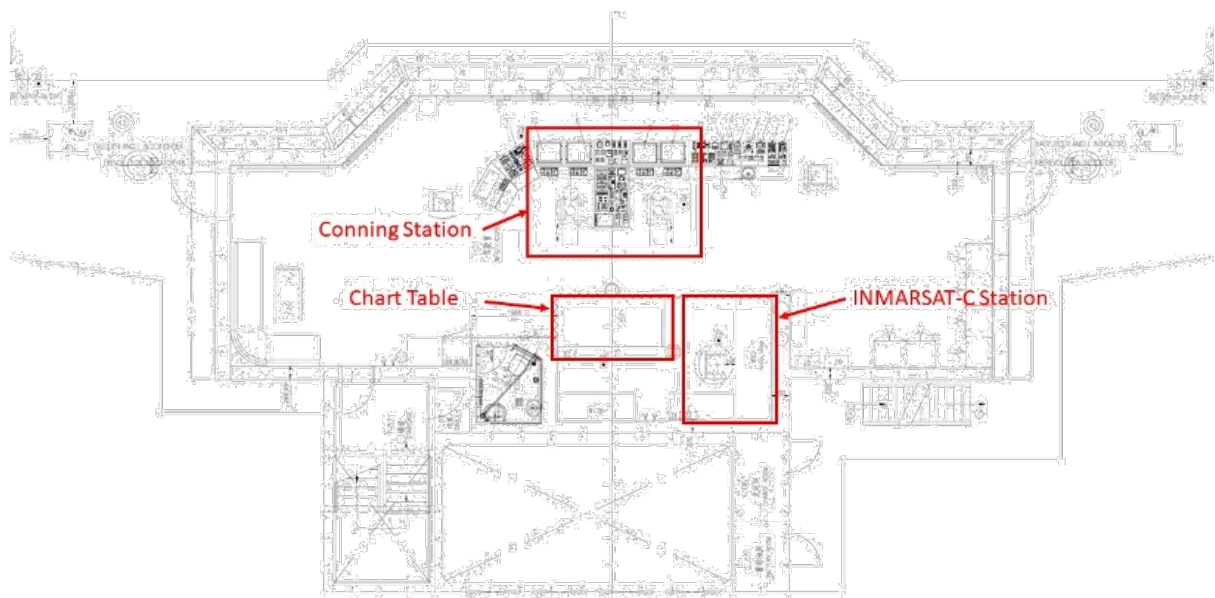
Figure 3: Layout of OLYMPIA's Bridge.

14. At 0900, the OOW went to the chart table (see Figure 3) to verify OLYMPIA's position and to make hourly entries in the Deck Logbook. The OOW would have had a clear view forward while standing at the chart table since the curtains in front of it were open.

19. The OOW reported that the INMARSAT-C station alarm activated at 0911. He said that he went to the INMARSAT-C station (see Figure 3) and reset the alarm. He also checked the messages that had been printed and then filed them. Based on the VDR recording, he had likely finished filing the messages by 0915.<sup>6</sup>

42. Based on SOLAS regulation V/22.1.1, the view from OLYMPIA's conning position (*see Figure 3*) of the sea surface directly ahead of the ship was required to not be obstructed by more than 344 m.<sup>9</sup>
43. The obstructed view of the sea surface from the conning position directly ahead of OLYMPIA when fully loaded and in ballast was:
