### PENELOPE CASUALTY INVESTIGATION REPORT

Provision Crane Maintenance Platform Failure with Fatality

Coral Sea | 26 November 2018

IMO Number: 9317822

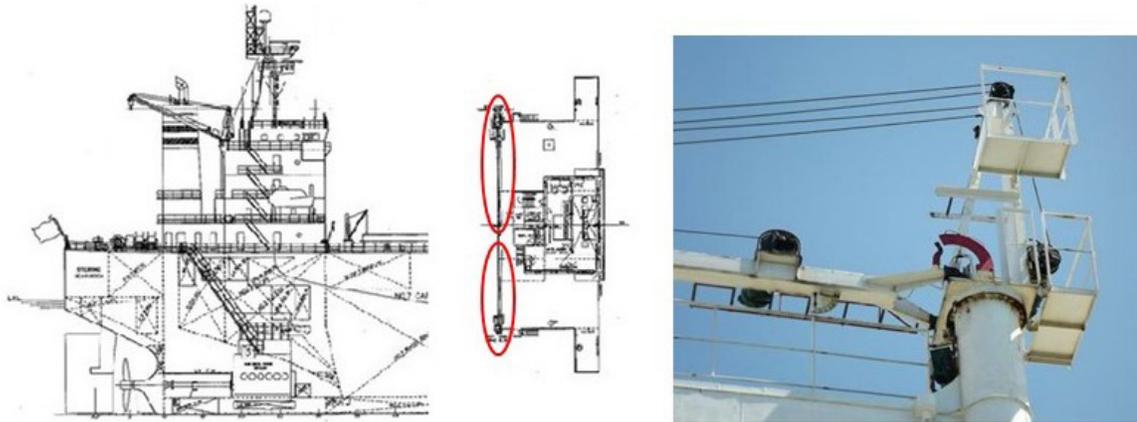
Figure 1: Portion of General Arrangement drawing showing the port and starboard provision crane locations, outlined in red on the plan view.<sup>1</sup> On the right is a picture of the starboard provision crane showing the upper and lower stages. The design of the port and starboard cranes was the same.

- The lower stage has two parts: the main platform (welded to the pedestal) and the platform extension. As built, the extension was attached to the main platform by three bolted connections (see Figures 1 and 2). There was no physical connection at the railing of the two parts.
