STELLAR BANNER CASUALTY INVESTIGATION REPORT

Grounding and Constructive Total Loss

Offshore Ponta da Madeira, Brazil | 24 February 2020

Official Number: 6941

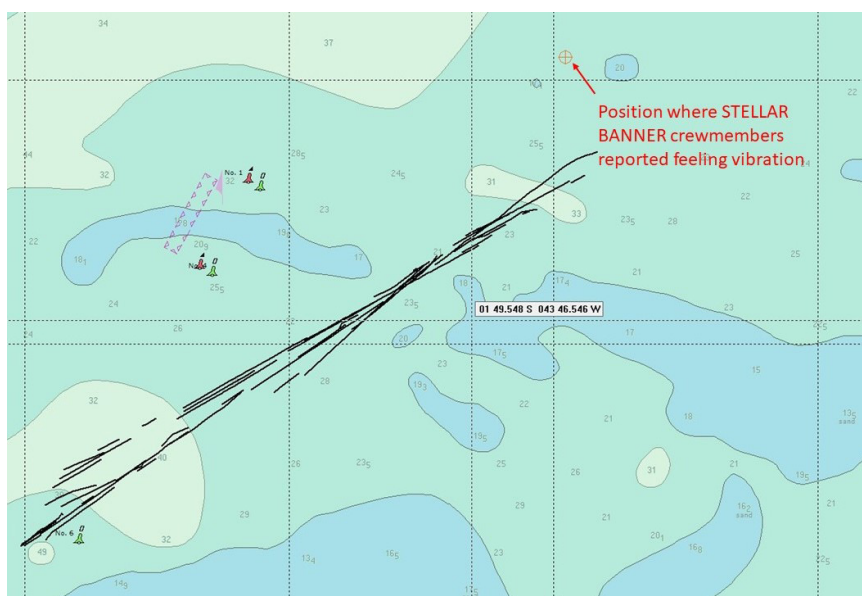
131. A summary of the outbound bulk carriers based on DWT³⁰ that left the approach channel in 2019 and passed through the sandbanks to the east of the buoyed channel is shown in the following table (see Figure 7):

Figure 7: Plot of AIS information for outbound VLOCs that in 2019 used a route similar to the one followed by STELLAR BANNER on 24 February 2020.³¹

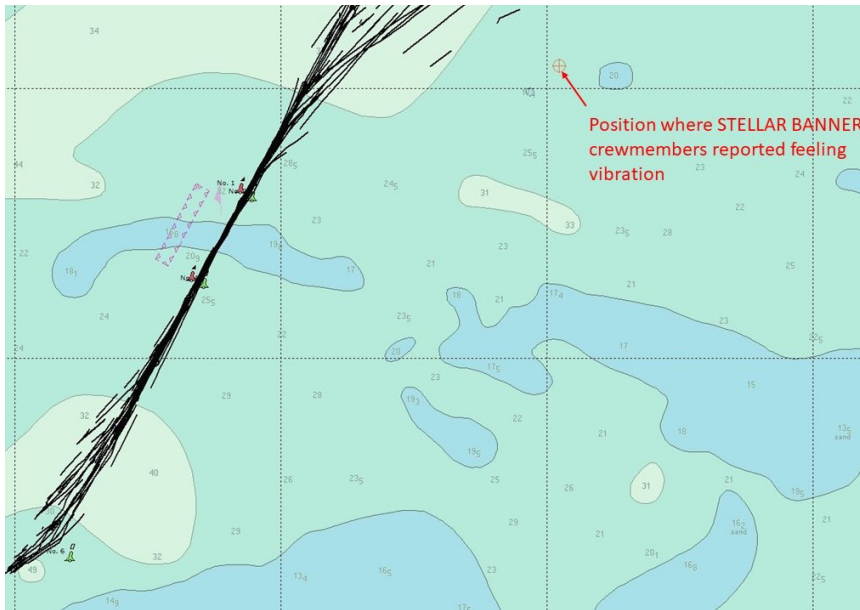
132. The AIS information indicates there were no outbound transits outside the channel by Company-managed bulk carriers in 2019 (see Figure 8).³²

Figure 8: Plot of all outbound transits by Company-managed ships in 2019.
