STELLAR DAISY CASUALTY INVESTIGATION REPORT

Loss of Buoyancy and Foundering with Multiple Loss of Life

South Atlantic Ocean | 31 March 2017

Official Number: 3486

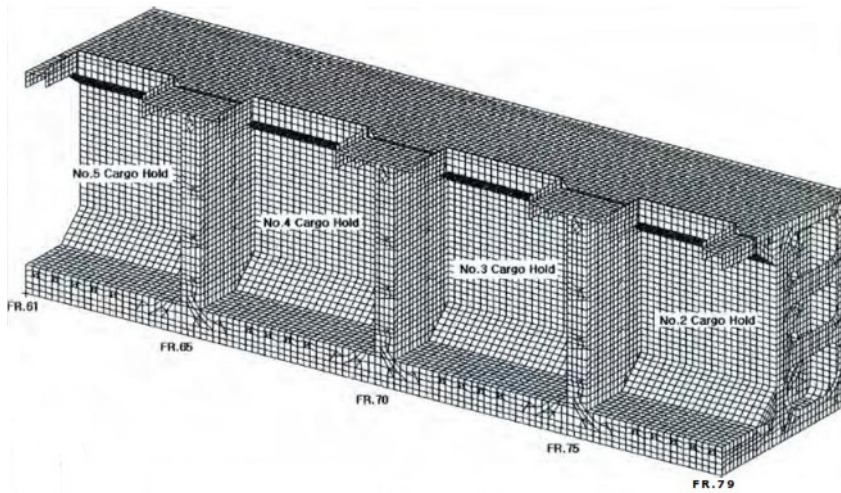
Figure 1: Midship half-breadth of STELLAR DAISY's hull that was modeled for the FEA. Note that Cargo Holds Nos. 3, 4, and 5 in the drawing refer to Cargo Holds Nos. 3F, 3A, and 4 on the General Arrangement Drawing.¹⁶

10. The FEA identified high shear stress in the web frame in way of where the new underdeck structure landed on the longitudinal bulkhead when the ship was loaded with a high density cargo. This was addressed by modifying the web frame to replace the existing grade AH plate with grade AH36 plate between longitudinal bulkhead longitudinals Nos. 5-7. The FEA also identified an area where the stress exceeded the allowed stress in the web frame in way of where the top of the hopper plate landed on the longitudinal bulkhead. The stress in this area was reduced by modifying the conversion design to include the installation of a girder at longitudinal bulkhead longitudinal No. 25 in each of the P/S voids and WBTs within the cargo length;¹⁷

12. The FEA concluded that although there were a number of areas where the stress was high, the conversion design was within the allowable limits for all loading conditions.²⁰

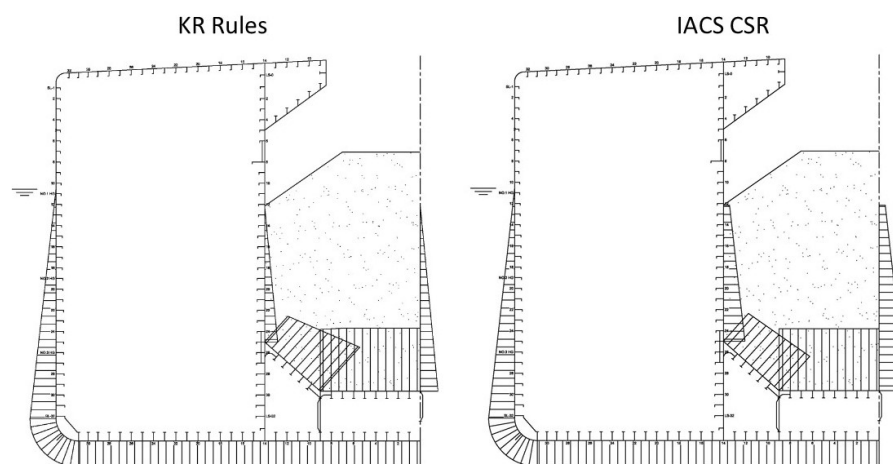
13. As part of the Administrator's marine safety investigation of the loss of STELLAR DAISY, Bruce S. Rosenblatt and Associates, LLC (BSR) was contracted to conduct an independent third-party FEA of the conversion design. The BSR FEA noted there was a difference between the cargo pressures on the boundaries of the cargo hold calculated using the KR Rules for Steel Ships and those calculated using the IACS Common Structural Rules, January 2006 edition as revised through Corrigenda 5 (CSR 2006, Corr.5) that were applicable when the design work for the conversion was being completed.²¹ These differences are most significant nearer the top of the cargo pile (*see Figure 2*). Therefore, load cases were developed and analyzed using both sets of rules. No areas of concern were identified with either load case. BSR did question whether these calculated pressures were adequate given that the pressure on the longitudinal bulkheads and supporting structure would increase due to the increased static list resulting from the flooding of wing tanks.²²

Figure 2: Scaled graphic representations of the static cargo pressures on the cargo hold boundaries based on KR Rules for Steel Ships (left) and IACS CSR 2006, Corr.5 (right). The pressures on the transverse bulkheads are shown to the right of the cargo pile.

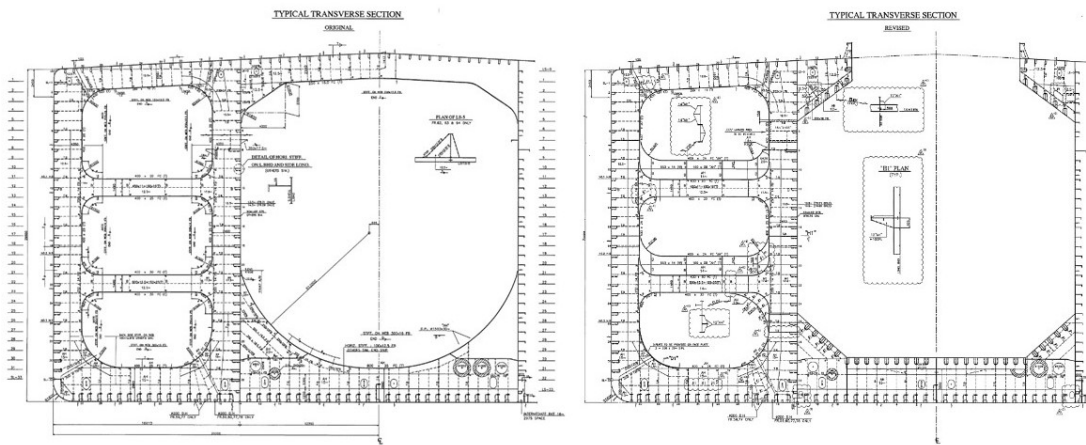
17. The structure of the main deck, side shell, and the bottom shell in way of the voids and WBTs on the port and starboard sides was not changed during conversion. In addition to removing cargo piping and other systems required for service as a crude oil tanker, the conversion required the completion of major structural work including:²⁷
- (a) installation of inner bottoms,²⁸ hoppers, and closed top side voids in each of the cargo holds (*see Figure 4*)²⁹;
 - (b) reinforcement of the transverse bulkheads between cargo holds by installing a second plate (*see Figure 5*);
 - (c) reinforcement of the longitudinal bulkheads between the cargo holds and the WBTs and voids;
 - (d) reinforcement of the two cross-ties at each web frame in the WBTs and voids (*see Figure 4*);

Figure 4: Typical transverse section. The original structure is on the left and the structure following the conversion is on the right.³⁰

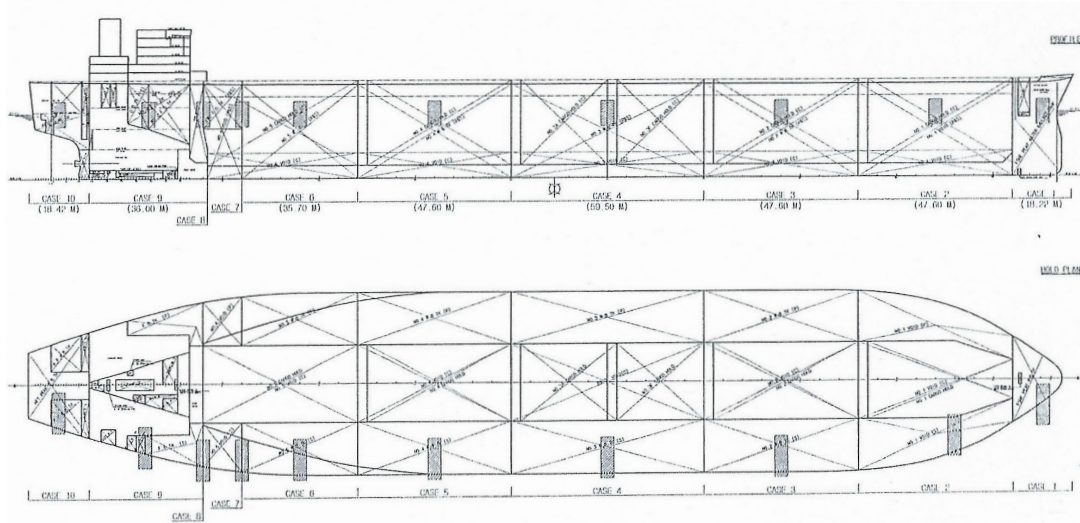
28. On 19 June 2009, KR approved the ship's intact stability and damage stability books.⁴² The approval was based on KR's determination that STELLAR DAISY complied with the requirements of the International Convention on Load Lines, 1966 as amended by the Protocol of 1988 (ICLL 1966 as amended by the Protocol of 1988), regulation 27(8) for a reduced freeboard assignment.⁴³ Ten damage conditions were considered as part of this determination. Of the seven damage conditions based on flooding of wing tanks in the cargo length, one involved flooding of Cargo Hold No. 1, which was sufficient to comply with the damage stability requirements of SOLAS regulation XII/4 (see Figure 7).⁴⁴

Figure 7: Damage conditions assessed to support the assignment of a reduced freeboard. The extent of the damage is shown by the grey rectangles. For the purpose of the assessment, it is assumed that the entire impacted space, or spaces, is flooded. (Source: Damage Stability Information.)

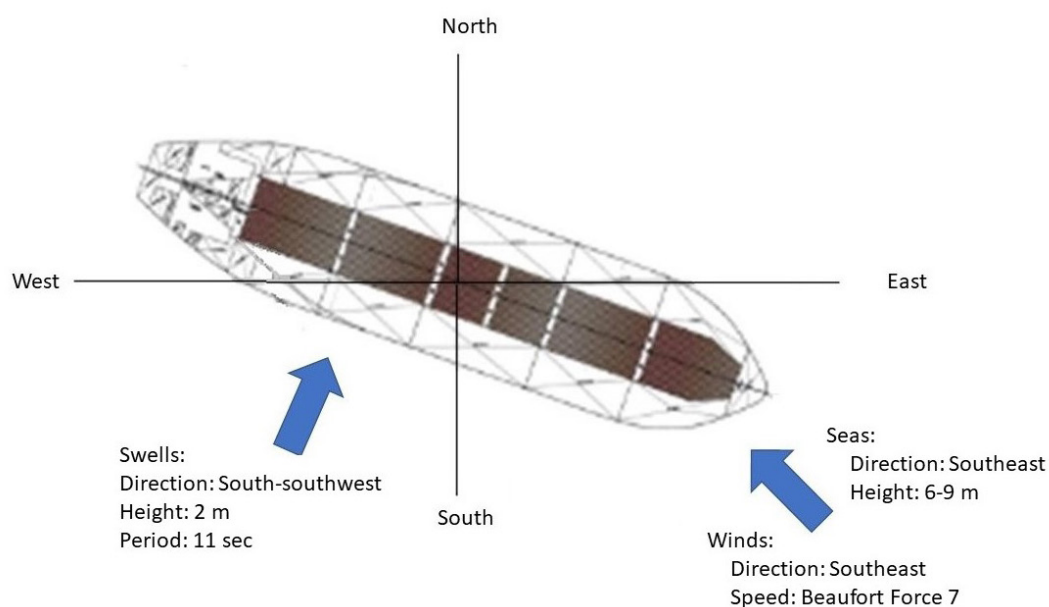
Figure 9: Wind and seas 29–31 March 2017.

After disembarking the Pilot on 26 March 2017, STELLAR DAISY maintained a southeasterly course toward the Cape of Good Hope. The weather worsened approximately two days after the ship's departure. Based on the ship's Noon Reports, Beaufort Force 7 winds and 6-9 m waves from the southeast were encountered for at least 72 hours before flooding was reported in the No. 2 P WBT. Based on the StormGeo forecast, there were also approximately 2 m swells from the southwest during this period (*see Figure 9*).

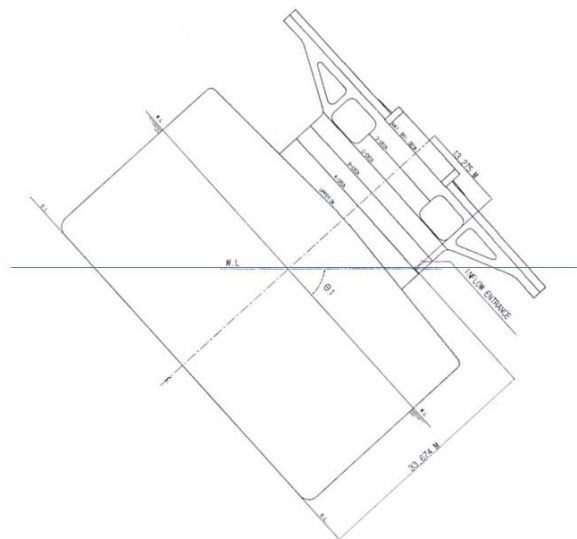
94. The AB stated that as the 3/O was making the distress call, he observed green water entering the Bridge through the door on the port side. He reported that the inclinometer indicated STELLAR DAISY had a 45° list to port (see Figure 10).¹³⁷ He also reported hearing a loud cracking sound on the port side but that he was not sure where it came from and that the ship rumbled like an earthquake. The AB reported he then ran out of the Bridge door and jumped into the water from the port side bridge wing. He did not provide an estimate of how long it was between when he first felt the ship start listing to port and when he entered the water.

Figure 10: Looking aft, waterline at a 45° list to port with a loaded draft of 20.2 m. The waterline shown does not take into consideration any draft increase due to flooding. (Source: Stability and Loading Manual.)

¹³⁷ Based on Polaris Shipping's calculations after STELLAR DAISY was reported lost, the down flooding angle was 43.338° , which is consistent with the value provided in the Stability and Loading Manual (p. 46).

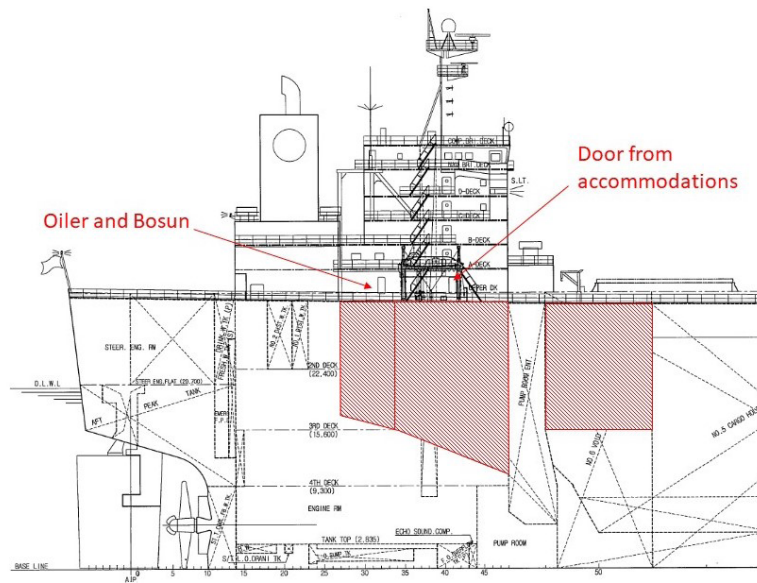
Figure 11: Location of Oiler and Bosun prior to the Oiler being washed overboard. The highlighted areas are fuel oil tanks (FOT). FOTs were in the same positions on the port side.

97. The Oiler described hearing what sounded like steel exploding. He then saw a wave of water and oil coming toward him from forward of the accommodations. The Oiler stated he was washed overboard when this wave hit him. The Oiler stated that he went underwater and was spun around before being pushed to the surface. He also stated the ship was gone when he surfaced and that he saw an immersion suit marked “BSN” floating nearby, which he grabbed. He then swam to a capsized life boat, which he stated was damaged on at least one side, and grabbed hold of it near the propeller. The Oiler put the immersion suit on while in the water in the vicinity of the life boat. After about 10 minutes, during which he reported calling out for other crewmembers and not receiving any response, the Oiler reported seeing two inflated life rafts, one of which was capsized, floating some distance away. He started swimming toward the life rafts while continuing to call for help.

The surviving Oiler reported he was washed overboard by a wave of water and bunker oil that came from forward of the accommodations. For this to occur, it was necessary for there to be a loss of structural integrity of one or more of the ship's FOTs and a loss of watertight integrity of the deck and side shell in way of frames Nos. 48-50 (*see Figure 11*).
