### TRF MANDAL MARINE SAFETY INVESTIGATION REPORT

Enclosed Space Fatality

Arabian Sea | 23 July 2022

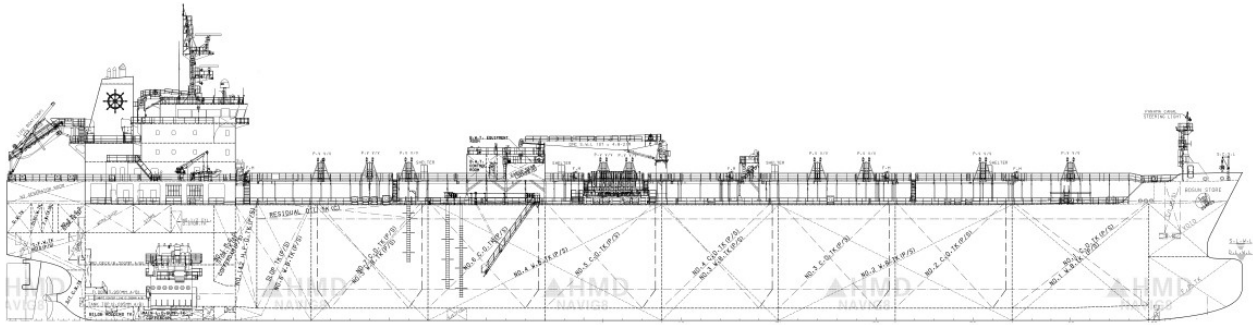
Figure 1: General arrangement of TRF MANDAL, profile view.

1. Ship particulars: *see* chart to right.
2. TRF MANDAL is an oil / chemical tanker with 14 cargo tanks and two slop tanks (*see Figure 1*).
