REPUBLIC OF THE MARSHALL ISLANDS

YENISEI RIVER MARINE SAFETY INVESTIGATION REPORT

Occupational Fatality

Pyeongtaek, Republic of Korea | 2 May 2024

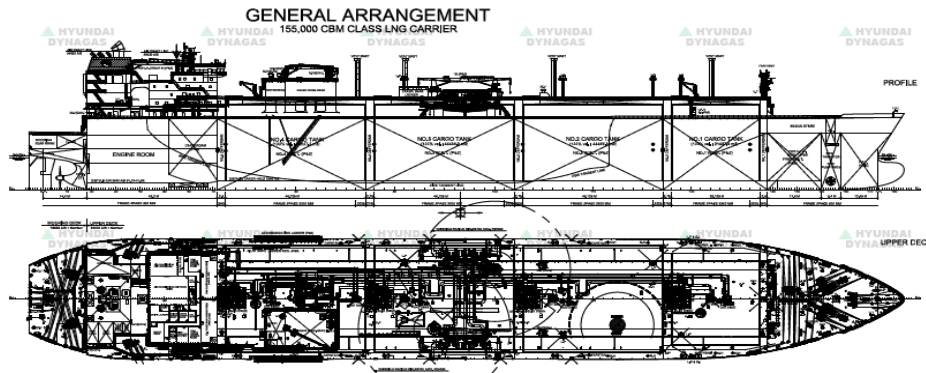
Figure 1: YENISEI RIVER General Arrangement.

YENISEI RIVER was built in 2013 in Ulsan, Republic of Korea, by Hyundai Heavy Industries, Co., Ltd. It is a 155,000 m³ Class LNG carrier with four cargo tanks (*see Figure 1*).

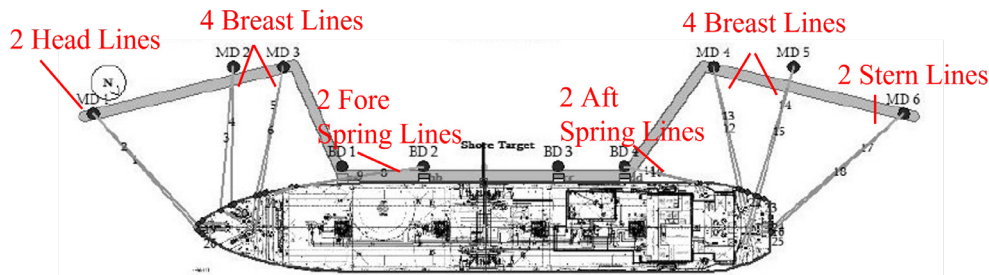
Figure 5: Mooring configuration as calculated.

On 28 March 2024, YENISEI RIVER departed Zeebrugge, Belgium to load LNG at Jetty No. 1 of the LNG terminal in the port of Pyeongtaek with expected arrival on 2 May 2024. A mooring configuration consisting of 16 lines in a 2-4-2 configuration fore and aft was calculated² and agreed with the LNG terminal before arrival.
